## ASSESSMENT OF TORNADOS WITH THE ENHANCED FUJITA SCALE IN ROMANIA

*C. NUCUȚĂ<sup>1</sup>, C. TIMIȘ<sup>2</sup>, C. BUȚIU<sup>3</sup>, O. SCRIDONESI<sup>1</sup>*

**ABSTRACT.** *Assessment of tornadoes with the Enhanced Fujita Scale in Romania.* An analysis of the damage caused by a tornado, in order to determine the maximum wind speed that was reached, is important both in terms of documenting the phenomenon and to make improvements to the evaluation method which is used, especially if this method is not specific for the analyzed territory. An overview of the way the tornado from Silivașu de Câmpie, on the 26<sup>th</sup> of May 2010, was termed EF2 is done to summarize the difficulties that arise in the assessment of tornadoes occurring in Romania with the Enhanced Fujita scale. The lack of correlation between damage indicators, different construction styles and building materials between those in the United States and those selected in this case study are the main issues addressed. Solutions for these issues are discussed as a starting point for the adjustment of Enhanced Fujita scale for Romania.

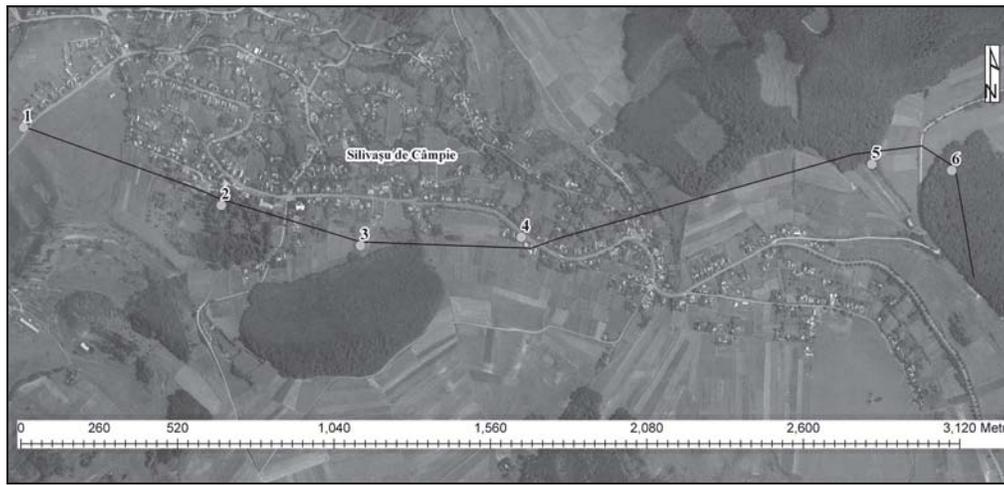
**Fig. 1. The damage indicators map**

For the evaluation of this tornado we considered six damage indicators, represented on a map in Fig. 1, representative because they are areas with the highest values of the damage from the tornado path.

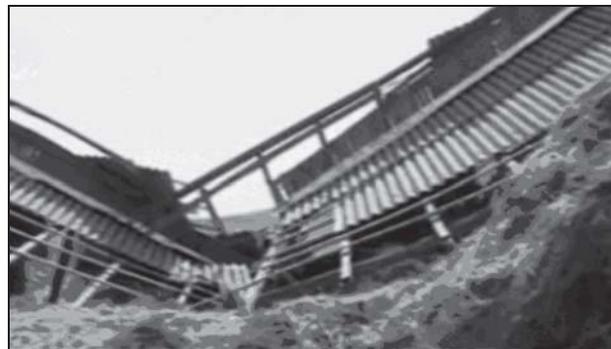
a) The first damage indicator is represented by a barn. Due to the predominance of wood as building material we considered it to be in the *Small Barns or Farm Outbuildings* category. Destruction of the supporting walls (Fig. 2), betrays the sixth degree of

**Fig. 2. The DI - Barn that has the supporting walls collapsed**

destruction of this damage indicator, with wind speeds of around 97 mph or 155.2 km/h. The age and poor quality of construction has led us to choose the lower bound of wind speed for this degree of destruction, 81 mph or 130.3 km/h.

In terms of building materials this construction fits perfectly into the chosen category, however there are certain construction elements that could increase the resistance of the walls and the roof so the wind speed that can produce the same damage should be higher. This is the first problem we have encountered. Thus, all these elements that increase the resistance of a construction represented by certain elements of construction, techniques and materials used, must be identified. The same should be done for the elements that reduce the strength of a construction, such as age, improper equipment or building materials that are not of good quality. These factors should be identified for each damage indicator, because they are different from one building to another.

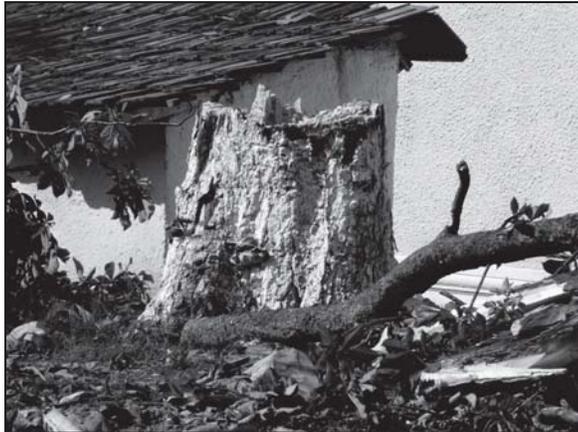
**Fig. 3. The second DI – A snapped chestnut tree trunk**

b) In the center of the village there is a natural reservation represented by a park. This is the next damage indicator. According to the local authorities, the park was affected at a rate of 30-40%. A chestnut tree trunk, about 20 cm in diameter, was snapped at about half of meter above the ground level (Fig. 3), indicating wind speeds up to 105 mph - 168.98 km/h. This is equivalent to the fourth

degree of destruction for the *Trees: Hardwood* damage indicator. Since this tree is the only one which had this degree of destruction, and the other trees in this location are just uprooted or suffered smaller degrees of destruction, we considered the lower limit of this indicator of damage, 93 mph or 149.66 km/h.

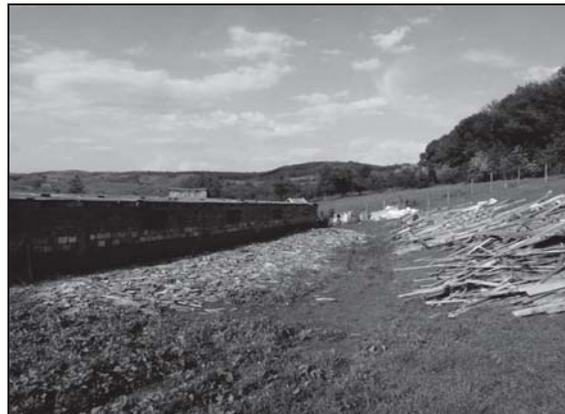
c) The next damage indicator is a stable. Although recently built (1996), with the resistance structure consisting of reinforced masonry walls (brick or concrete blocks), the roof structure composition (roof structure with rafters) is disregarding the standards for bearing and joining, with wood shingle roofing of average quality, it can not be classified in another category than the *Small Barns or Farm Outbuildings*. Uplift of roof structure is corresponding in the sixth degree of destruction, with estimated wind speeds up to 93 mph - 149.66 km/h.

**Fig. 4. The Third DI – Uplift of roof structure of an stable**

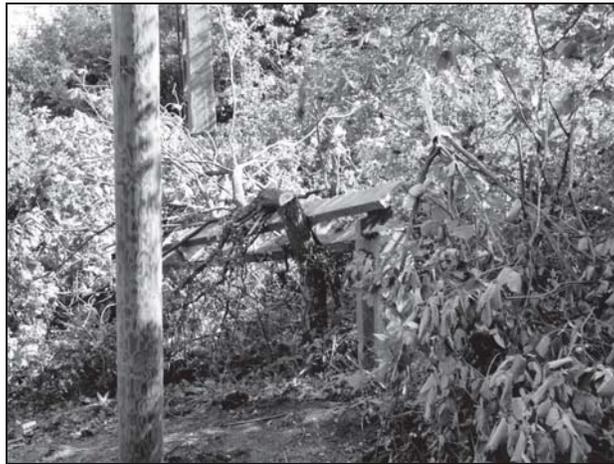
e) The next damage indicator is centered on an electricity pole which is made of pre-stressed concrete and was broken at about 1 m above the ground. It was considered to be in the *Electrical Transmission Lines* category. The wind speed that could cause this damage is about 138 mph, the fifth degree of destruction. We have taken into account the fact that this post was placed in the forest and the trees

**Fig. 5. The fifth DI - Broken electrical transmission lines**

that fell over it could cause damage to the structural strength. Thus, a wind speed of around 125 mph - 201.16 km/h is more probable.

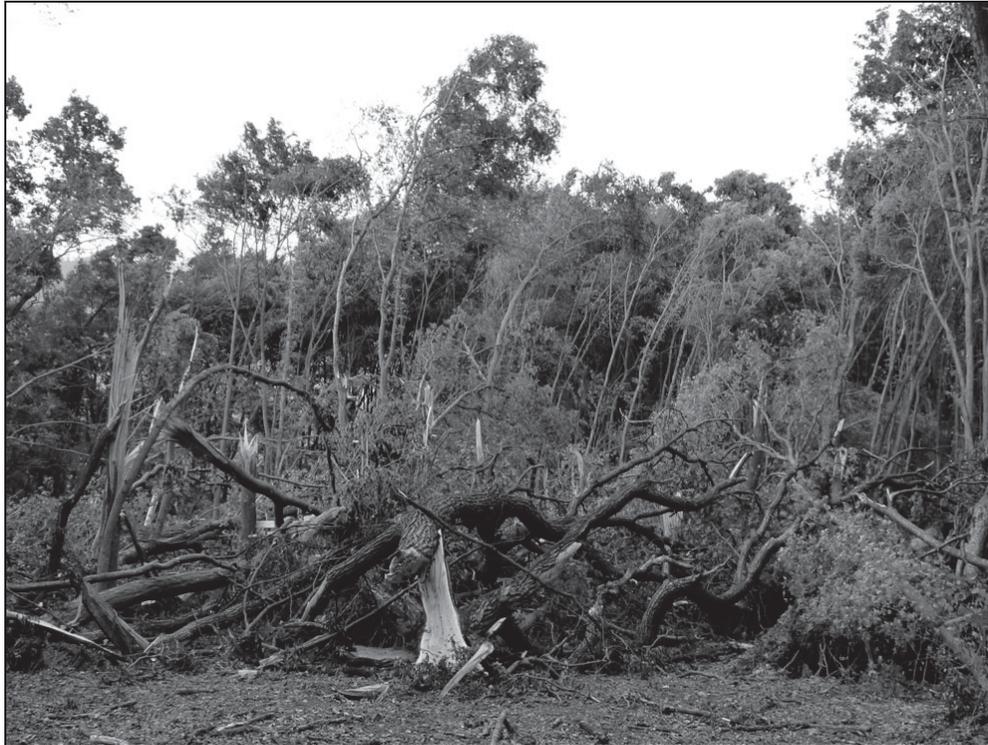
f) The last damage indicator is represented by an area of 3 hectares of a beech forest, where over 90% of trees were flattened. It falls under the *Trees: Hardwood* category and in addition to trees which the vast majority fall within the fourth degree of destruction *broken trunks*, there are *trees debarked with only stubs of largest branches remaining*, falling in the highest degree of destruction, the fifth,

which corresponds to wind speeds of 143 mph. Since there is only one example of this degree of destruction, we did not consider the average value for this level of destruction, but a lower value of 135 mph - 217.26 km/h.

**Fig. 6. The last DI - Broken trunks in a deech forest**

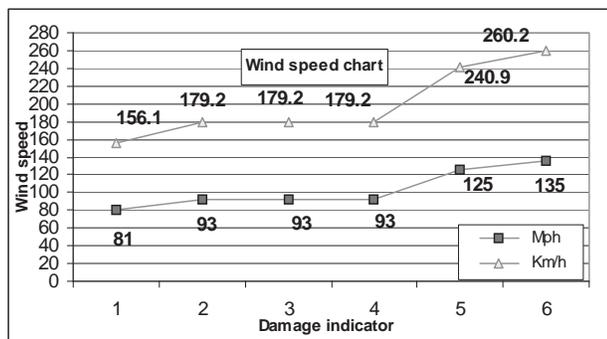
**Fig. 7. The wind speed chart along the six damage indicators**

Fig. 7 presents the evolution chart of the wind speed in mph and km/h along the tornado path, speed determined by the degree of destruction of the damage indicators.

The EF intensity is determined individually for each damage indicator and finally the tornado is assigned the maximum

value of all indicators. In this case it can be clearly seen that the wind reached speeds of 125 - 135 mph or 201.16 - 217.26 km/h at the last two damage indicators. This means that the tornado was an EF 2.
