THE SEPTEMBER 2013 RAIN AND FLOOD EVENTS IN THE FLAM'S VALLEY BASIN. CAUSES, CHARACTERISTICS AND THEIR IMPACT UPON THE ENVIRONMENT

BORCAN MIHAELA,¹ FLOREA CRISTINA, TROCEA I., NEDELUCU G.

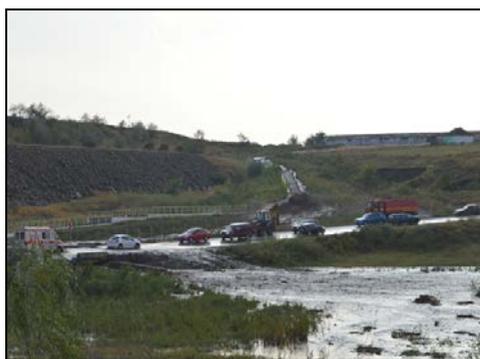
Fig. 4. Overflow over the bridge on DN 22

- Flow obstruction by the bridge over the channel caused flooding in the area situated downstream of the red sludge pond. A portion of about 20 m of the channel (downstream of the bridge to the stilling pool), was heavily damaged (the concrete ditch was heavily dislocated). The lack of energy absorbers throughout the tailrace channel led to overflow over the bridge on DN 22.

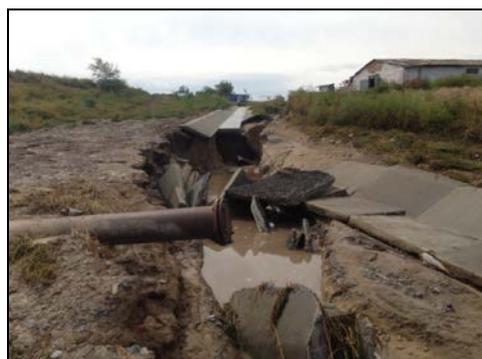
Fig. 5. Displaced concrete ditch downstream the red sludge pond

- On the western channel, the concrete ditch was dislocated on a stretch of about 15 m by the water torrent. Also dislocation of the concrete ditch of about 30 m in length, have been reported in the main channel (deflection channel),

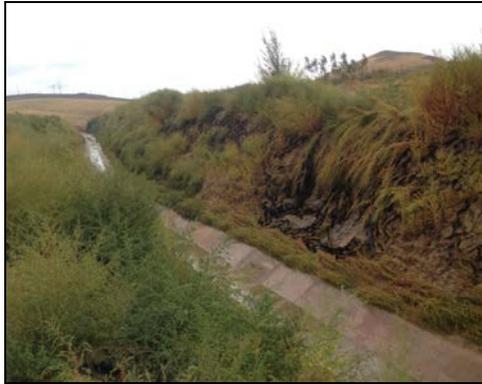
The channel has slopes covered with abundant herbaceous vegetation (Fig. 6). The channel has a south to north flow direction expanding over a length of about 1200 m until the concrete tubing bridge which facilitates the access into the sludge pond perimeter (Fig. 7).

Fig. 6. Herbaceous vegetation on the edges of the channel

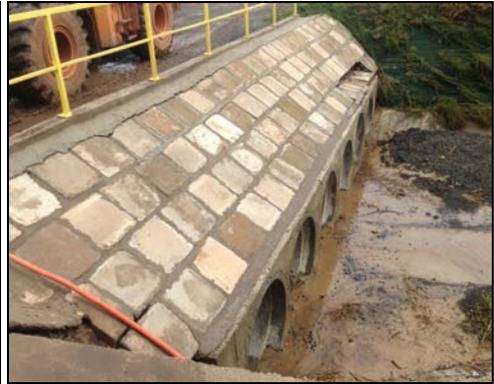
Fig. 7. Bridge over concrete tubing

As a key feature of this channel it may be signaled that in the bridge area located on concrete tubing the channel is reduced in size and its transport capacity diminished and as a consequence the flood water inundated the surrounding area.

- The bridge over the channel (installed on concrete tubes) presents some protective plates dislocated,

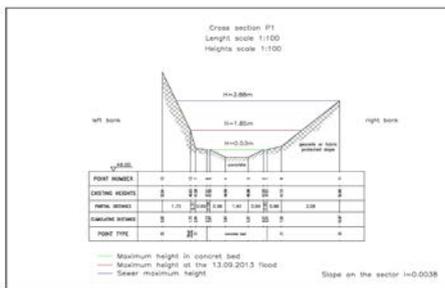
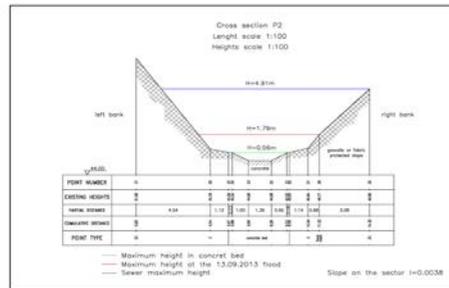
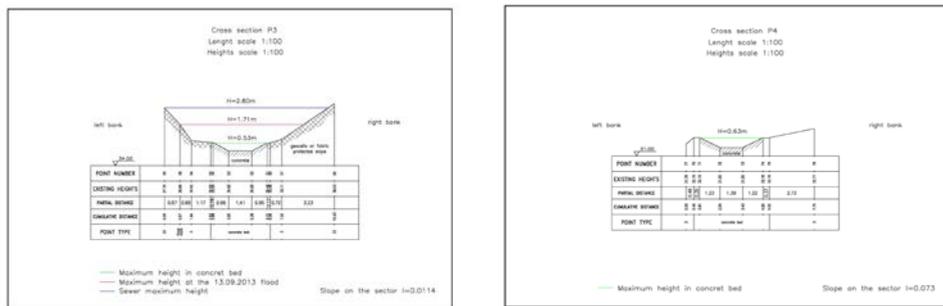
Fig. 8. Transversal sections along Flam's Valley channel

- On the lower part of the channel (at the concrete tubing bridge) the flow section is reduced (see profile no. 3), the existence of the bridge preventing a smooth drainage.

- Downstream of the bridge the section is reduced only to a concrete ditch (profile no. 4) which obviously cannot transit the maximum flood flow. Consequently the surrounding area is flooded.
