THE ANALYSIS OF RIVER BANK EROSION ALONG ȘIEU RIVER

MIOARA CHIABURU, M. DULGHERU

Key words: bank erosion, bank retreat mass failure, monitoring, damage

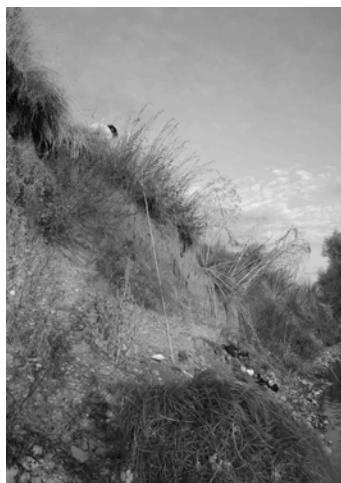
Fig. 3. Arcalia- Bank profile 3 measured in 04.10.2008

Bank river stratigraphy is very complex and includes several sedimentary layers, particularly for Arcalia site, with a cohesive upper portion (layers 3-5), overlying a gravel toe (layers 1-2) in the upper part of the bank. The average height of the banks ranging from 4 to 5 meters in the two cases. (Fig.2, 3, 4, 5)

Bank retreat process is more obvious for Arcalia experimental site (Fig.8,9, Tabel 1), a pronounced evolution occurring for the third profile, more than 60 cm bank retreat being recorded. Inside the bank, the overgang has 6,2 meters, and the upper bank is still anchored by grassy roots.

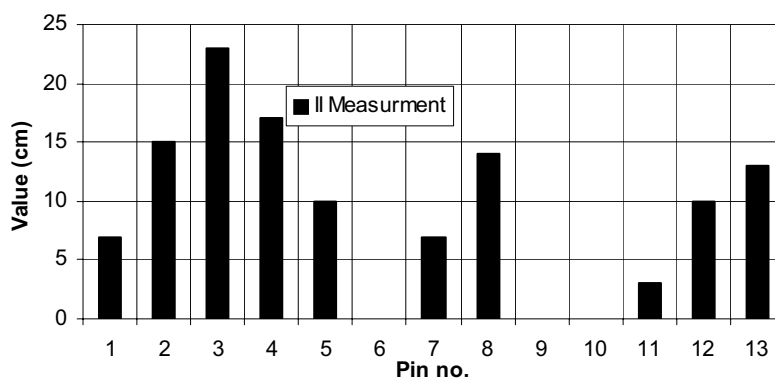
Fig. 8. Șieu-Sfântu bank retreat (cm) values for bank retreat between 06.12.2008 and 25.01.2009

For Șieu-Sfântu experimental site the measurements doesn't recorded yet spectacular evolutions, as those from Arcalia site (Fig. 8), but the value for each centimeter of eroded bank has a higher value, the land being cultivated at one meter from the bank margin (Fig.5).
