INCORRECT PROPOSAL OF RUNOFF DRAINAGE THROUGH INFILTRATION FACILITY - CASE STUDY

*G. MARKOVIC¹, V. ONDREJKA HARBULAKOVA²,
Martina ZELENAKOVA³*

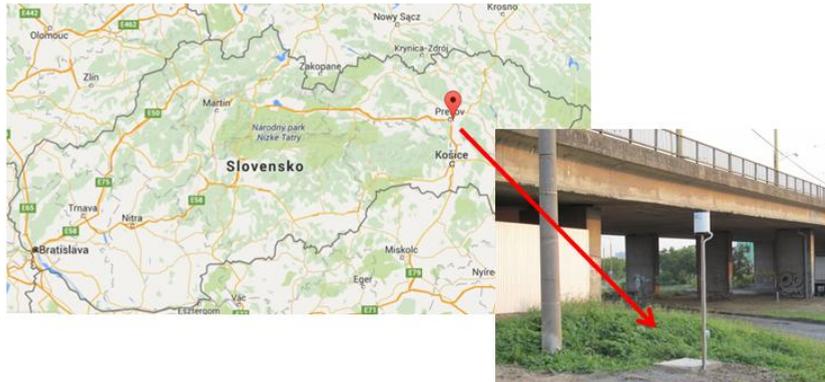
Bridge object (Figure 1) is located on road 1/8 between Prešov and Kapušany. Approached two-way road on the bridge contains 4 lanes. It is bridge road over the train and local road MK Sekčov and road III/06815. Roadway on the bridge has one-sided slope 1.5% (Markovič and Vranayová, 2013; Zeleňáková and Rejdovjanová, 2014).

Fig. 1. Studied bridge object

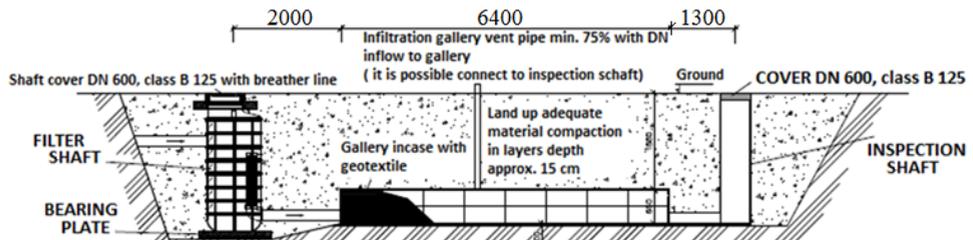
Figure 2 shows the location of measuring equipment and objects for research. Rainwater from the bridge flows into filter shaft, which serves for capture and sedimentation of coarse and fine impurities. The rainwater subsequently flows into the infiltration gallery, where the water is filtered during infiltration to the soil. A flow meter is located in the filter shaft, which record incoming rainwater in l/s. The water level in the infiltration gallery can be monitored by means of the float-gauge which is located in inspection shaft. Near this infiltration gallery is located rain-guage.

Fig. 2. Infiltration gallery – longitudinal section

The percolation gallery is formed by plastic units. The percolation area of the infiltration gallery is 46.08 m². Its surface is rectangular. They are designed according to standard ATV - DVWK - A 138 Design of infiltration modules of rainwater which is used in the most of EU states.

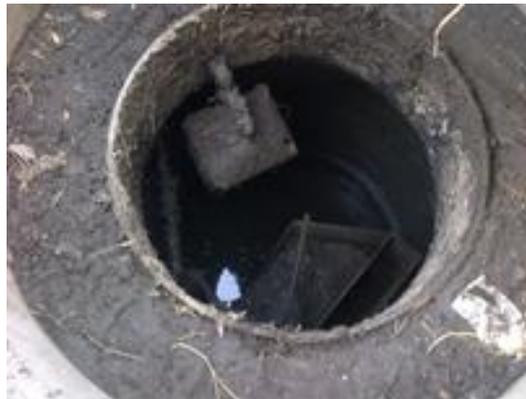
But results from laboratory test set infiltration coefficient in area of interest as $4.84E-07$ m/s. It means about 100 times lower infiltration efficiency and also lower accumulation volume of infiltration gallery as was design for safe disposal of rainwater runoff. This results to insufficient infiltration rate of this percolation gallery. Infiltration coefficient $4.84E-07$ m/s represents practically impermeable type of soil not suitable for infiltration facilities. Unfortunately this inaccurate design caused flooding and silting all infiltration gallery and result to failure of installed devices for research (Figure 3).

Fig. 3. Flooded filter shaft with measurement devices

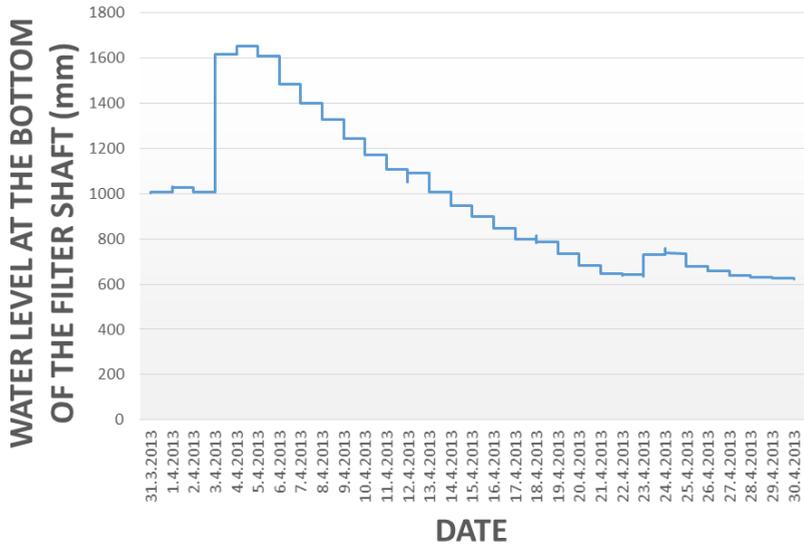
Figures 4-6 represent typical process of rainwater percolation in infiltration gallery respectively water level in gallery during the month of April, May, and June 2013. Data from research showed that there was continuously high water level in percolation gallery. This represents a very low infiltration rate of this infiltration gallery what is given by the coefficient of infiltration of soil at the bottom of gallery determined as $k_f = 4.84E-07$ m/s and also means overflow of percolation gallery.

Fig. 4. Water level variations at the bottom of filter shaft during April 2013

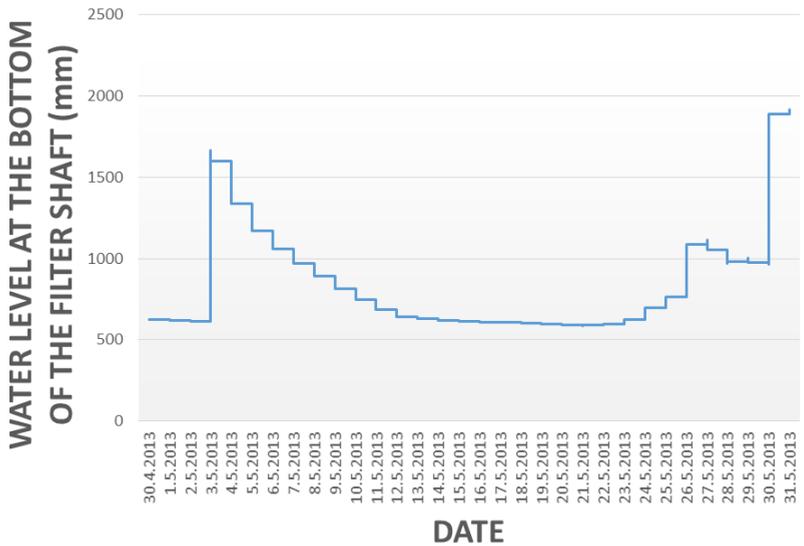
Fig. 5. Water level variations at the bottom of filter shaft during May 2013

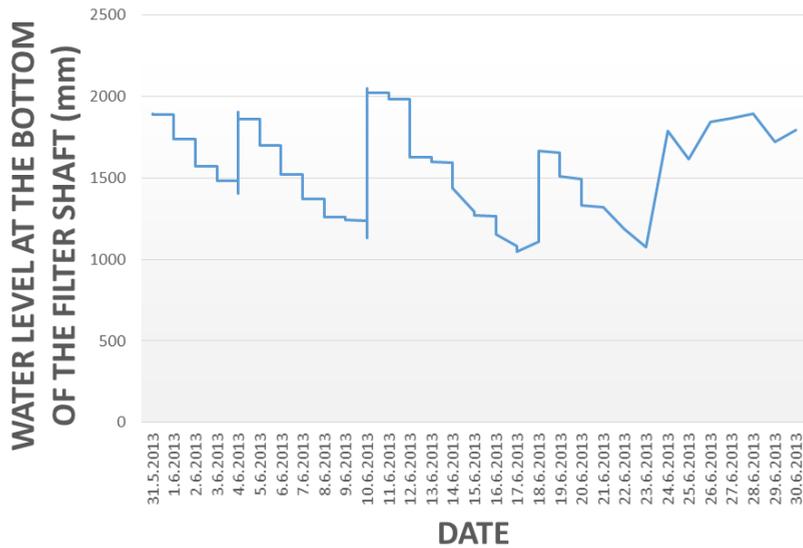
Fig. 6. Water level variations at the bottom of filter shaft during June 2013
