EFFECTS PRODUCED BY THE FLASH-FLOOD FROM JUNE 1-2, 2019 IN THE DRAINAGE BASIN OF THE PIAN, RACHITA AND CIOARA RIVERS (MUREŞ DRAINAGE BASIN)

ABSTRACT. The area affected by the floods that took place during 1st - 2nd of June 2019 is located in the southern part of Alba county, where significant precipitation had fallen in a very short time. The Pianu, Cioara si Rachita catchment areas are not monitored either from a hydrological or from a rainfall point of view. The rapid floods formed on the Pianu, Cioara and Răchita rivers with their cadastral and non-cadastral tributaries caused great damage in 4 municipalities (Pianu, Săsciori, Săliştea and Şibot): there were flows and extraordinary levels on Răchita and Cioara rivers. The largest damages were recorded in Pianu and Săsciori municipalities, whereas the lowest ones were enlisted at Şibot. The greatest destruction was made by Răchita river, that is 5 km long, followed by Pianu River. The flash floods affected households, institutions, county roads, street roads, forest roads, water and sewage networks, sewage plants, electricity and gas networks, telephony networks, cultural centres, shops, bridges, footbridges, pedestrian bridges,

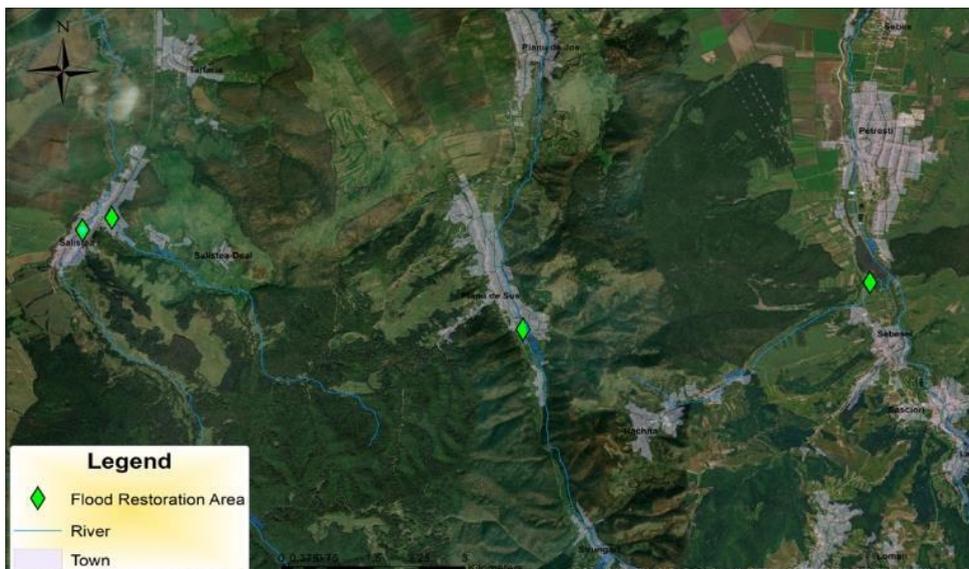
Fig. 2. Flood Restoration Area

The Pianu catchment area is adjacent to the east with the Sebeş river basin, with its tributary Răchita, and to the west with the Cioara (Valea lui Stan) river. (fig 2).

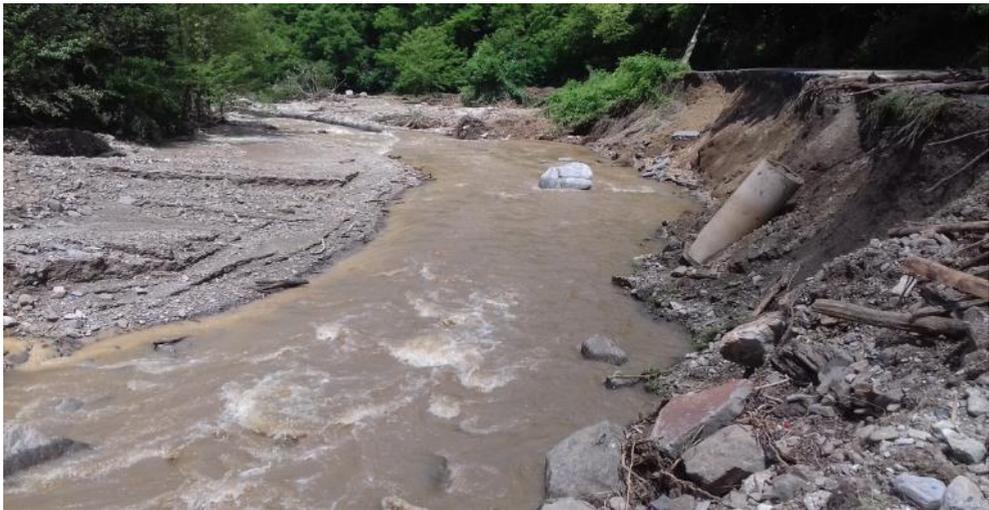
Fig. 3. Riverbed and communal road erosion – downstream of Strungari village – photo C.A. SAFTA

In the radius of Pianu village, the leakages from the slopes, torrents and the important water discharges which flowed in a very short time have silted the riverbed of Pianu river over a 10 km length. 9 bottom sills were destroyed whereas 5 bottom sill were clogged. There were two sectors on the river Pianu where the riverbed silted – first, between the villages of Strungari and Pianu de Sus (Fig.3), and the second between Pianu de Sus and Pianu village, where a pitch caused a riverbed change, the river forming a new one (PM5).

The water-course regulation works were affected as follows: 0.19 km gabion wall bank protection, 0.018 km embankment shore protection, 1.3 km flood defence works. The thalweg of Pianu river riverbed deepened over a length of 1.4 km and the banks were eroded over a 0.55 km length [4,5].
