ASSESSMENT OF ACCIDENTAL WATER POLLUTION WITH MINE WATERS IN ROMANIA WITHIN 2017-2023

ABSTRACT. – Assessment of accidental water pollution with mine waters in Romania during 2017-2023. Against the background of an increasingly restricted mining activity at the national level, due to the high economic costs, the active and conservation mining objectives sporadically register environmental incidents, which affects mainly the aquatic environment. Thus, in the context of excess rainfall, internal erosion processes associated with dikes and structures related to tailings ponds, poor management of the galleries under conservation can lead to the triggering of accidental pollution with mine waters and wastewaters from tailing ponds of the natural hydrographic network. The analysis of these events was done both from the perspective of spatial and temporal distribution, with a focus on the nature of involved polluting substances and the transfer of pollution waves on the local and regional hydrographic network system. The paper used information from the database of the Romanian National Water Administration, obtained as a result of the post-event investigations carried out through the Wate

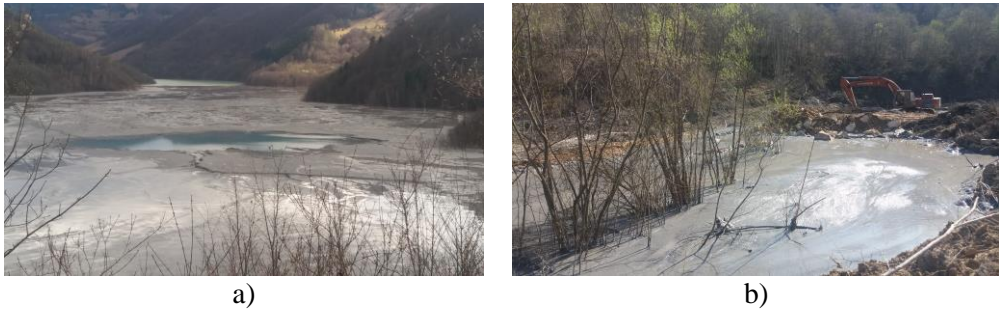
The April 2017 incident at the Valea Şesii tailing pond was due to an internal erosion phenomenon, caused by the blocking of the reverse well, used to evacuate the cleared water to river network. The initial/temporary system for evacuating this water from the pond used the diversion works of the Valea Sesii stream during the execution of the priming dam. The initial system consisted of a clear water evacuation system with reverse wells on Valea Şesii and an evacuation system on Valea Cărbunarilor. The systems were made of *PREMO* Dn 800 mm pipes that connected downstream to the circular gallery with a diameter of 2.5 meters, made of reinforced concrete. The drainage system continued below the dam with a rectangular closed channel, also made of reinforced concrete, downstream up to the natural riverbed of Valea Şesii creek.

Fig. 2. Valea Şesii tailing pond: a) internal suffusion cone in the stabilized area; b) temporary works downstream of dam to contain the pollution event (source: Ciungan, C., 2017)

After the clear water discharge system was put into operation, the collector pipe from the provisional system of reverse wells failed in the dam undercrossing area. In the first phase the situation was remedied by closing downstream and stopping the flow of water and tailings. In 1998, the water intake, routing and evacuation system was decommissioned, the reverse wells were concreted, and the closed channel was blocked with a concreted metal gate over which a layer of earth and stone was deposited. In September 2016, at the Valea Şesii pond, traces of tailings were observed around a water source downstream of the dam, referred to by the exploitation staff as an outbreak. The source of the outbreak was the infiltration through the mass of tailings towards the gallery break, of rainwater and clear water. The hydrotechnical drillings carried out in the tailings beach revealed the fact that there was a wet area at a height of 1-2 meters under the surface of the beach, which explains the small flow rate of the outburst of about 3 l/s.

On April 3rd, 2017, the occurrence of a larger outbreak was observed, through which wastewater was discharged, the phenomenon was reported to the Alba Water Management System and further on the information flow to the Ministry of the Environment, Waters and Forests. The mining company has made several interventions to mitigate the pollution by building two temporary dams to keep the wastewaters from reaching the Arieş River and stopped the operation of the ore

preparation plant (Figure 2). The Alba Water Management System has decided to operate the reservoir of Mihoiești, in order to generate downstream a bigger flow to cope with the pollution events for dilution purposes. The monitoring campaign was focusing on collecting water samples from the affected area and from downstream collecting streams: Arieș and Mureș rivers.

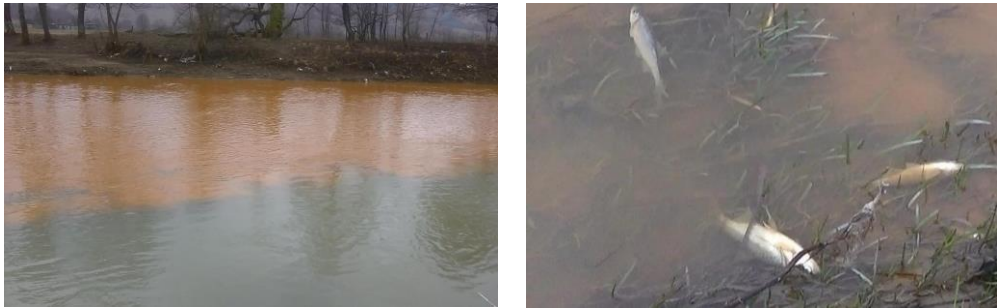
The pollution of the Lăpuș river with mine waters from the Breiner mining gallery, Băiuț commune, Maramureș county on March 27th, 2018 lasted for several hours. The monitoring of the events was done by collecting sample along the river length, both on Lăpuș river and on its collector, Someș river. The maximum iron concentration at the pollution source was 487.8 mg/l, it decreases to 1.989 mg/l at Rogoz, and in the Someș river after the confluence with the Lăpuș river it was 3.302 mg/l influenced by the iron concentration in the Cavnic rivers, Săsar, Baița and Nistru creek.

Fig. 3. Pollution wave caused by acid mining drainage from Băiuț mining site with confirmed fish mortality on Lăpuș River (source: Buda, M., 2020)

The maximum concentration of manganese at the pollution source was 54.2 mg/l, it decreases to 2.79 mg/l at Rogoz, and in the Someș river after the confluence with the Lăpuș river it was just around 1.391 mg/l. The maximum concentration of zinc at the pollution source was 92.9 mg/l, it decreases to 3.73 mg/l at Rogoz, and in the Someș river after the confluence with the Lăpuș river it was 1.032 mg/l. The maximum copper concentration at the pollution source was 4.495 mg/l, it decreases to 0.12 mg/l at Rogoz, and in the Someș river after the confluence with the Lăpuș river it was 0.053 mg/l.

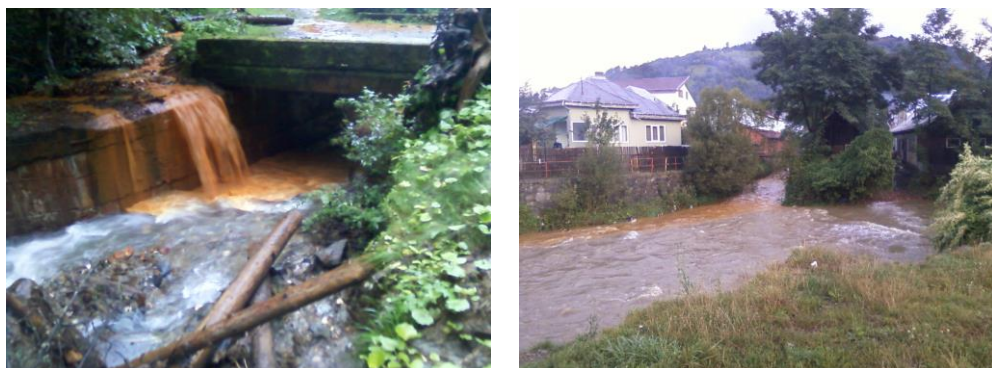
In the Valea Vinului conservation mining area, Rodna commune, Bistrița-Năsăud county, three incidents of mine water pollution, originating from the Gheorghiu Gallery, were recorded. The first event was on August 10th, 2017, the second one, between 23-24th of April, 2018 and the third one on October, 18th, 2019, when the mining waters were discharged into the Băilor stream through the bypass of the Valea Vinului treatment plant (Figure 4). As in the similar cases presented before the mine waters were loaded with heavy metals. The 2017 pollution recorded the highest loading of cadmium (154.15 $\mu\text{g/l}$, compared to 0.51 $\mu\text{g/l}$ or 1.44 $\mu\text{g/l}$), zinc (58.602 $\mu\text{g/l}$, compared to 39.51 $\mu\text{g/l}$) and copper (110 $\mu\text{g/l}$, against 17.33 $\mu\text{g/l}$).

Fig. 4. Pollution wave caused by mining drainage from Valea Vinului on Izvorul Băilor creek and Someșul Mare River (source: Dragotă, C. M., 2017)

The nickel loading was close in 2017 and 2019, 42.68 $\mu\text{g/l}$ and 46.68 $\mu\text{g/l}$, but in 2018 it was below the detection limit. In 2018, the waters had the highest loading of iron 128.58 mg/l and manganese 43.08 mg/l .

Immediately after entering the river, the concentration of the pollutant drops a lot by about 10 times, for example, lead drops from 18.23 $\mu\text{g/l}$ to 2.73 $\mu\text{g/l}$; nickel decreases from 46.68 $\mu\text{g/l}$ to 4.26 $\mu\text{g/l}$; total copper decreases from 17.33 $\mu\text{g/l}$ to 1.6 $\mu\text{g/l}$; iron decreases from 21.79 mg/l to 2.31 mg/l and manganese decreases from 12.44 mg/l to 1.4 mg/l .

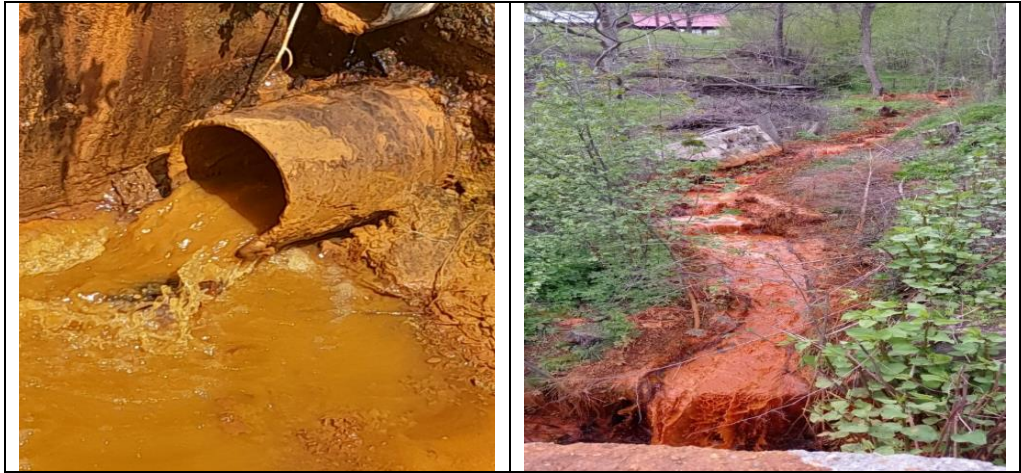
Pollution of the Bistrița river with mine waters from the Isipoaia Mine, Suceava county, which polluted the waters of the Bistrița River from May 13th 2023 at 19.30 until May 17th, at 08.45, on the Broșteni section downstream of Holda, up to 5 km border with Neamț county (Figure 5). This part of Siret river catchemnet is often affected by mining drainage from abandoned olt mine sites (Zait, 2021). From the whole studied period this was the longest running pollution of waters loaded with heavy metals (iron, manganese, zinc, copper and lead).

It is observed that the highest value was recorded immediately after the incident 700 m downstream from the pollution source, after which it continuously decreased.

Fig. 5. Pollution wave caused by mining drainage from Isipoaia site on Bistrița River (source: Dănăilă, I., 2023)

The variation of manganese concentration in the Bistrița River varied between 0.146 mg/l before the pollution source, reaching values of 0.215 mg/l downstream of the pollution source, we can say that there was no manganese pollution.

The variation of copper concentration in the Bistrița River varied between 10.31 µg/l before the pollution source, reaching values of 159.8 µg/l downstream from the pollution source, at 700 meters and 52.09 µg/l at 1500 meters downstream of the pollution source on the first day.

The variation of zinc concentration in the Bistrița River suddenly increased above the detection limit, reaching the value of 247 mg/l at 700 meters downstream of the pollution source, decreases to 68 mg/l at 1500 meters, and then decreases below the detection limit. The variation of the lead concentration in the Bistrița River suddenly increased above the detection limit, reaching the value of 2.66 $\mu\text{g/l}$ 700 meters downstream of the pollution source, decreasing to 1.579 $\mu\text{g/l}$ at 5000 meters, then decreasing below the detection limit.
